**SUNAPEE LAKE TOWN DAM
NH 00108**

**PHASE I INSPECTION REPORT
NATIONAL DAM INSPECTION PROGRAM**

MAY 1979

Identification No.: NH00108
Name of Dam: Sunapee Lake Town Dam
Town: Sunapee
County and State: Sullivan, New Hampshire
Stream: Sugar River
Date of Inspection: June 6, 1978

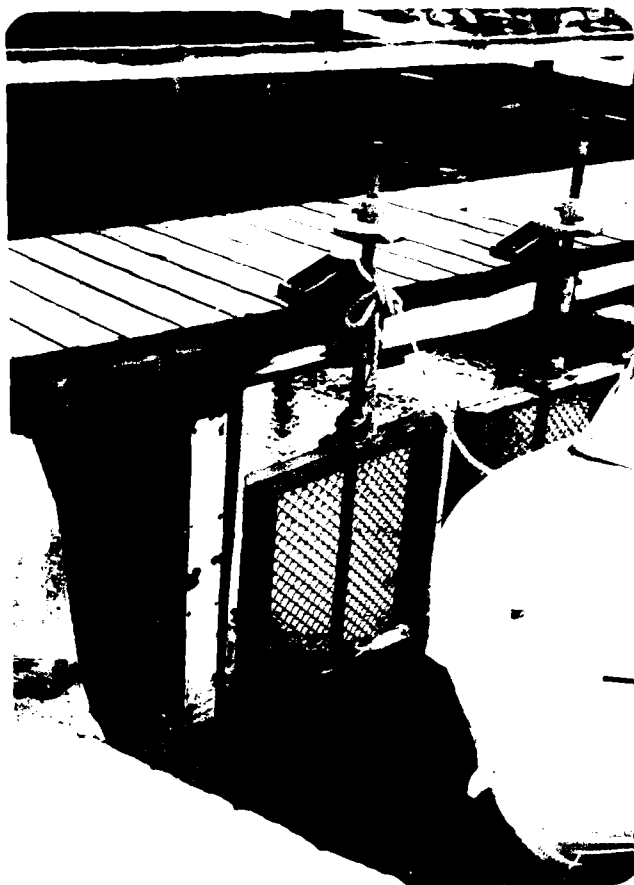
15. Fish Screens at the
"Upper Lake Dam,"
Looking Downstream.
